UNDERGROUND CAR PARK DOHA, QATAR

Project Date: February 2016

Repair and Strengthening - CCL Qatar

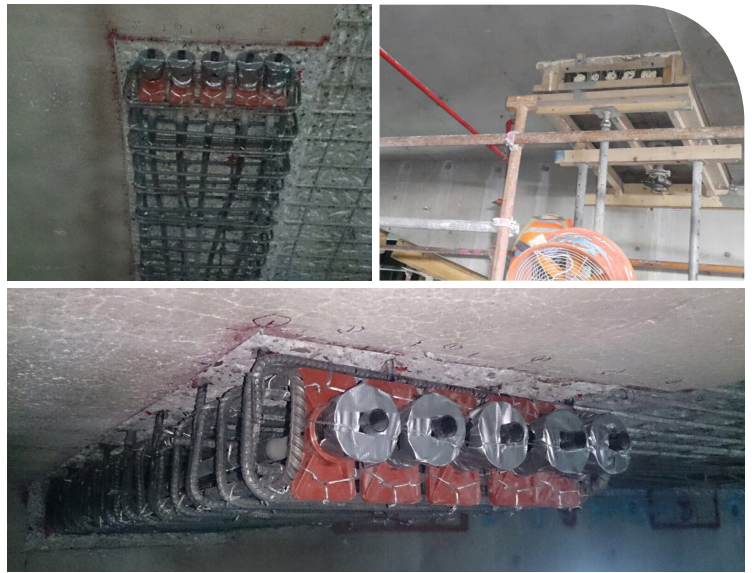
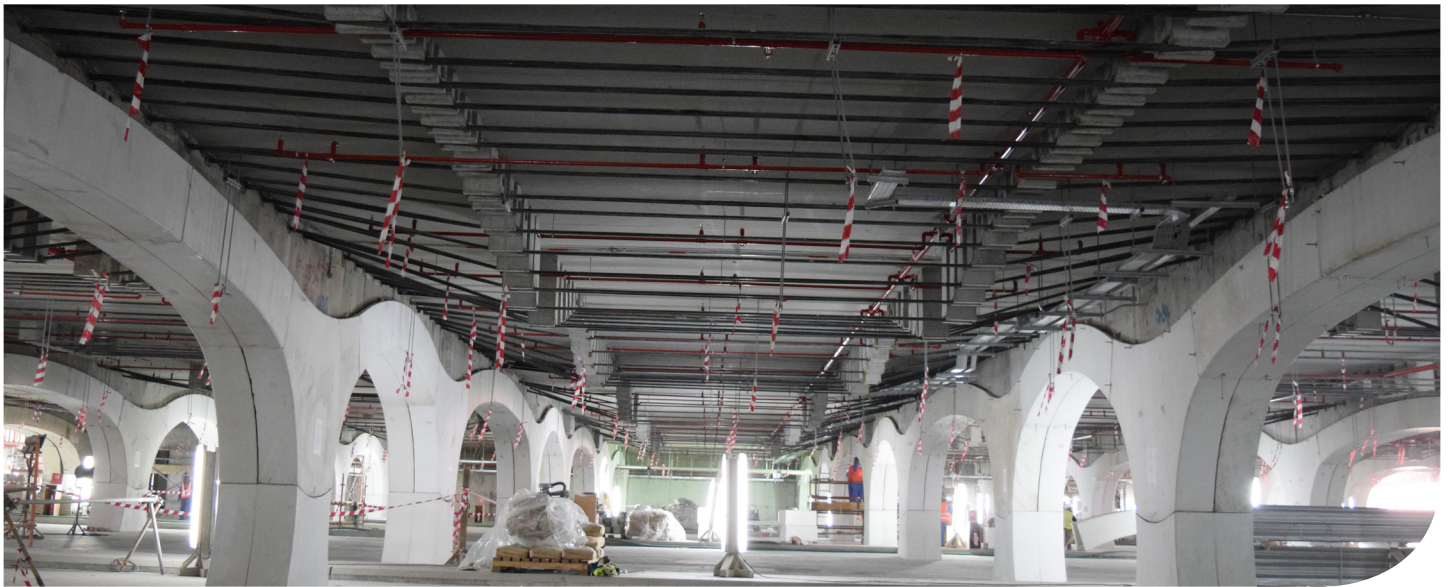
In order to determine the extent of the damage to the affected areas of the structure, CCL undertook a thorough investigation, the results of which identified the necessary remedial actions. These included refurbishment using fully-encapsulated unbonded external post-tensioning systems, replacement of the affected bottom reinforcement and reinstatement of the concrete.

Because a significant depth of concrete was lost as a result of the fire and because the location of the damage meant there was no access to cast the replacement concrete from above, CCL carried out the restoration using the form and pump technique.

This involved installing formwork to create a cavity around the affected area into which the concrete was pumped.
